Property Inspection Report

Peace of Mind Home Inspection

Property Address: 123 some ware
City State Zip: Marysville WA 98271

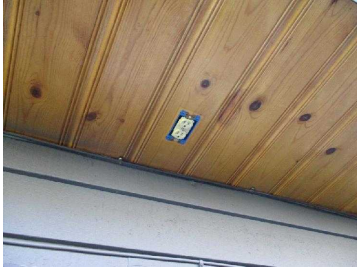
13. Exterior Electric Outlets: 110 VAC GFCI - **On the right of the garage the outlet on the eve has no cover plate. Recommend installing a cover plate for electrical safety.**

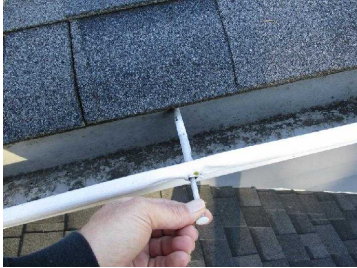
11. Gutters: Aluminum - On the left upper roof there is a nail that came loose it is only nailed into the fascia. Recommend to move the nail so it will go into the end of the roof rafter.

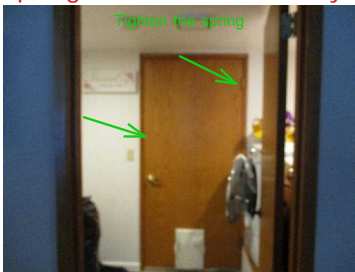
5. Exterior Surface: Cedar siding
6. Roof: Asphalt shingle
7. Roof Structure: Unable to inspect garage is sheet rocked
8. Service Doors: Fire rated - **The spring hinge is not set tight enough. Recommend to tighten the spring so the door shuts by all the way by itself.**

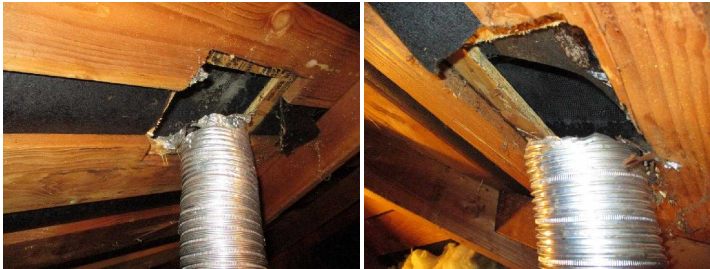
13. Bathroom Fan Venting: Electric fan/ windows - **There is two bath vents that are terminated in the attic at a roof vent not there own vent. Recommend a licensed roofer to estimate and evaluate to re-vent the bath vent to there own vents.**

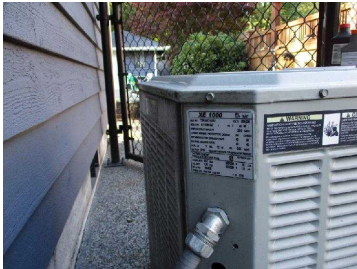
1. A/C System Operation: Functional - **There is no service dates on the A/C unit. Recommend a HVAC company to estimate and evaluate to service the A/C unit.**

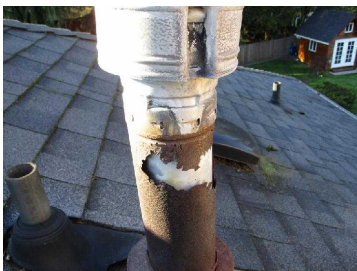
2. Manufacturer: Trane
3. Model Number: TDD080R936EO Serial Number: R514S9B1G
4. Type: Wall recessed resistance Capacity: 80,000 Btu
5. Area Served: Whole building Approximate Age: Not present
6. Fuel Type: Natural gas
7. Heat Exchanger: 4 Burner
8. Unable to Inspect: 0%
9. Blower Fan/Filter: Direct drive with disposable filter
10. Distribution: Insulflex duct
11. Circulator: Pump
12. Draft Control: Automatic
13. Flue Pipe: Double wall - **Where the flue terminates on the roof the roof jack is rusted. Recommend a licensed roofer to estimate and evaluate to replace the roof jack.**

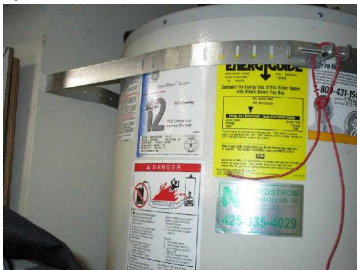
1. Service Line: Copper
 2. Main Water Shutoff: Garage
 3. Water Lines: Copper
 4. Drain Pipes: ABS
 5. Service Caps: Accessible
 6. Vent Pipes: ABS
 7. Gas Service Lines: Cast iron
- Garage Water Heater
-
8. Water Heater Operation: Adequate - **There is no service dates on the hot water tank. Recommend a licensed plumber to estimate and evaluate to service the hot water tank.**

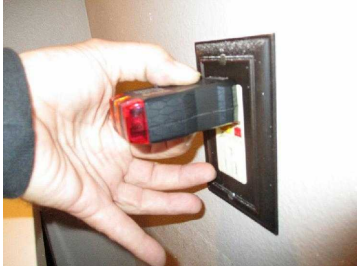
7. Electrical: 110 VAC GFCI - **The GFCI outlet will not trip when testing. Recommend a licensed electrician to estimate and evaluate to replace the outlet.**

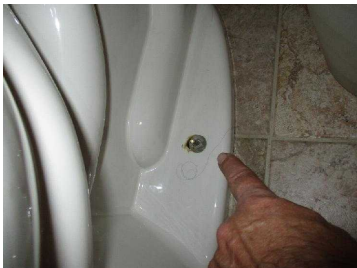
46. Toilets: 1 1/2 Gallon Tank - The toilet is really loose. Recommend a licensed contractor to estimate and evaluate to re-set the toilet and possibly the closet flange.

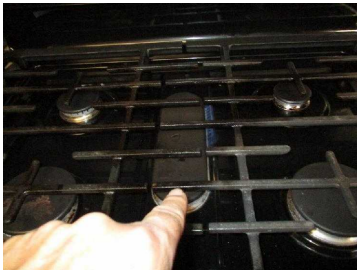
1. Cooking Appliances: N/A - **The warming burner is not burning all the way it may have plugged burner ports. Recommend to have the stove serviced by a qualified service company.**

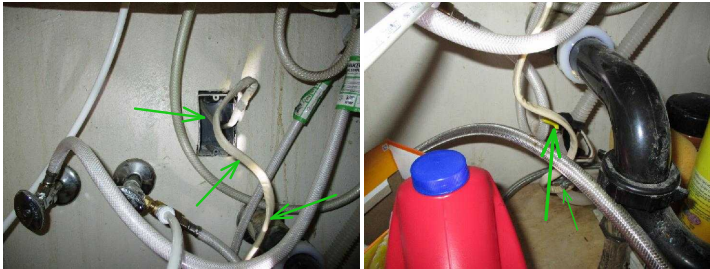
10. Electrical: 110 VAC GFCI - The outlet under the sink there is exposed wires and no cover on the electrical box. Recommend a licensed electrician to estimate and evaluate to put the wires in the box with an outlet and cover.

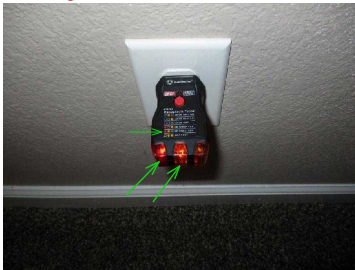
25. Doors:
26. Windows: Aluminum slider
27. Electrical: 110 VAC - To the right of the back door the outlets hot and neutral are reversed.
Recommend a licensed electrician to estimate and evaluate to correct the wiring for electrical safety.

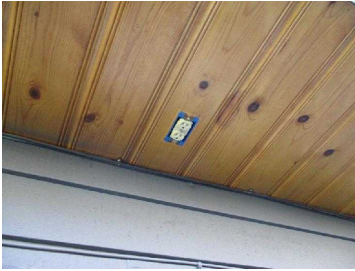
1. Exterior Electric Outlets: 110 VAC GFCI - **On the right of the garage the outlet on the eve has no cover plate. Recommend installing a cover plate for electrical safety.**

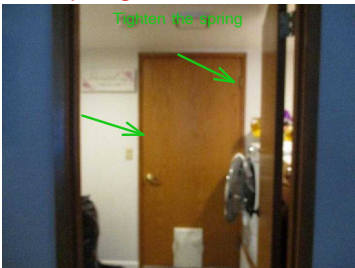
2. Attached/Front Garage Service Doors: Fire rated - **The spring hinge is not set tight enough. Recommend to tighten the spring so the door shuts by all the way by itself.**

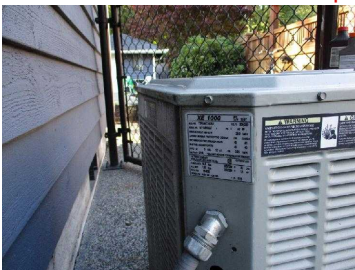
3. Out side of house AC System A/C System Operation: Functional - **There is no service dates on the A/C unit. Recommend a HVAC company to estimate and evaluate to service the A/C unit.**

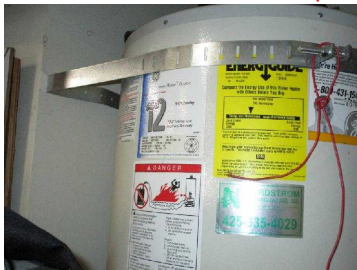
5. Garage Water Heater Water Heater Operation: Adequate - **There is no service dates on the hot water tank. Recommend a licensed plumber to estimate and evaluate to service the hot water tank.**

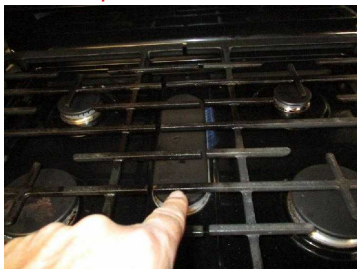
6. 1st Floor Kitchen Cooking Appliances: N/A - **The warming burner is not burning all the way it may have plugged burner ports. Recommend to have the stove serviced by a qualified service company.**

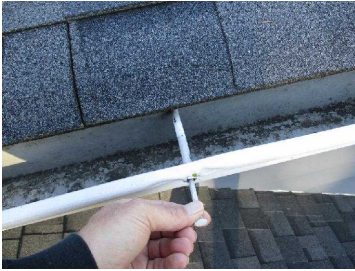
1. Gutters: Aluminum - On the left upper roof there is a nail that came loose it is only nailed into the fascia. Recommend to move the nail so it will go into the end of the roof rafter.

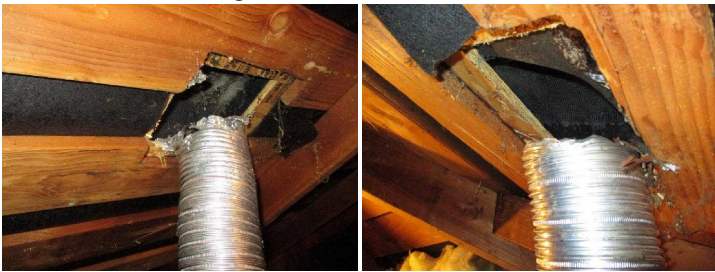
3. Main Attic Bathroom Fan Venting: Electric fan/ windows - There is two bath vents that are terminated in the attic at a roof vent not there own vent. Recommend a licensed roofer to estimate and evaluate to re-vent the bath vent to there own vents.

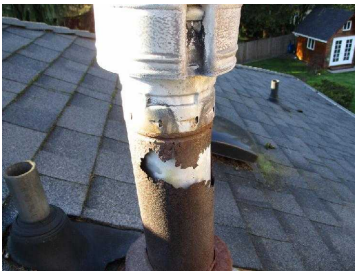
4. Garage Heating System Flue Pipe: Double wall - **Where the flue terminates on the roof the roof jack is rusted. Recommend a licensed roofer to estimate and evaluate to replace the roof jack.**

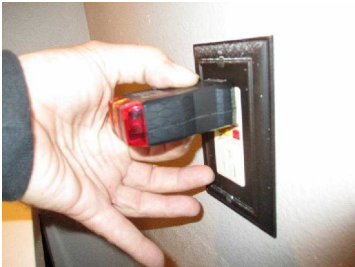
5. 1/2 bath, 1st floor main Bathroom Electrical: 110 VAC GFCI - **The GFCI outlet will not trip when testing. Recommend a licensed electrician to estimate and evaluate to replace the outlet.**

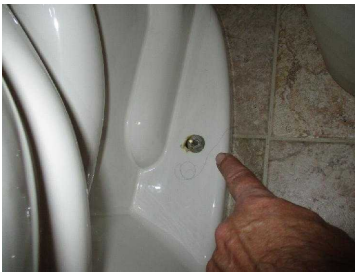
8. Master Bathroom Toilets: 1 1/2 Gallon Tank - **The toilet is really loose. Recommend a licensed contractor to estimate and evaluate to re-set the toilet and possibly the closet flange.**

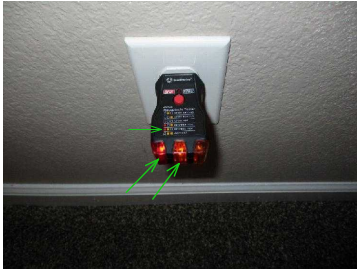
10. Family Room Living Space Electrical: 110 VAC - To the right of the back door the outlets hot and neutral are reversed. Recommend a licensed electrician to estimate and evaluate to correct the wiring for electrical safety.
