Property Inspection Report

721 91st Ave S.E.
Lake Stevens , WA 98258

Peace of Mind Home Inspection

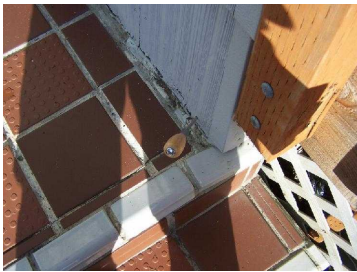
7. Patio Door: Solid wood w/ Glass window
8. Windows: Vinyl slider - The trim on the window in the front on the right side of the door has small amount if rot. The Back window also is showing some rot. Recommend a contractor to estimate and evaluate to replace the trim.

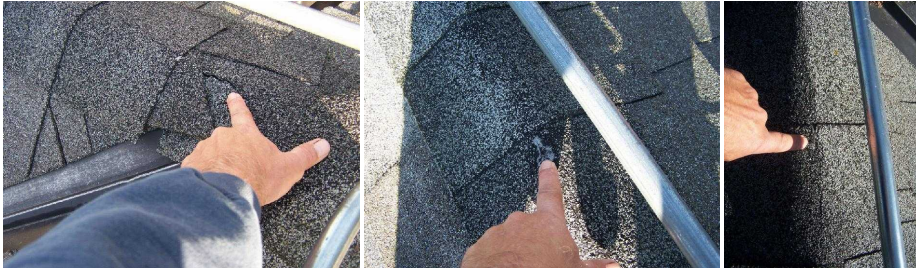
Main Roof Surface _____

1. Method of Inspection: On roof
2. Unable to Inspect: 0%
3. Material: Asphalt shingle - **Some of the roof shingles are broke, cracked or worn. Recommend a roofer to estimate and evaluate to replace the ridge cap that is not in good shape.**

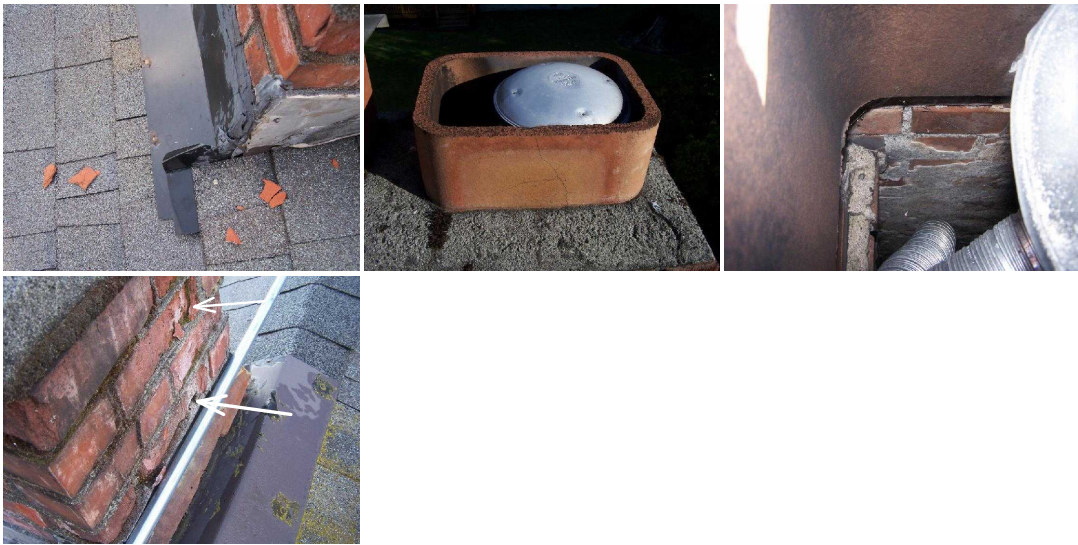
On ridge line, North Chimney _____

14. Chimney: Brick, Metal pipe - **Some of the bricks are starting to flake off. Recommend repairing as necessary.**

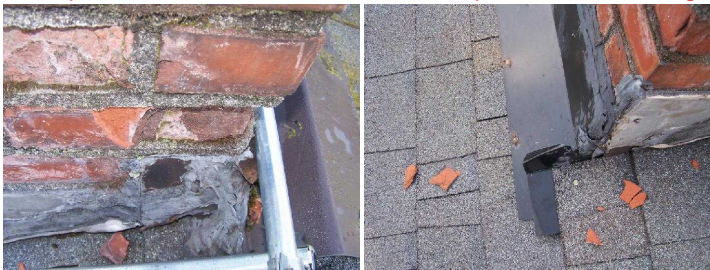
16. Chimney Flashing: Galvanized - Most of the flashing has been caulked. Recommend a chimney sweep to estimate and evaluate to replace the flashing.

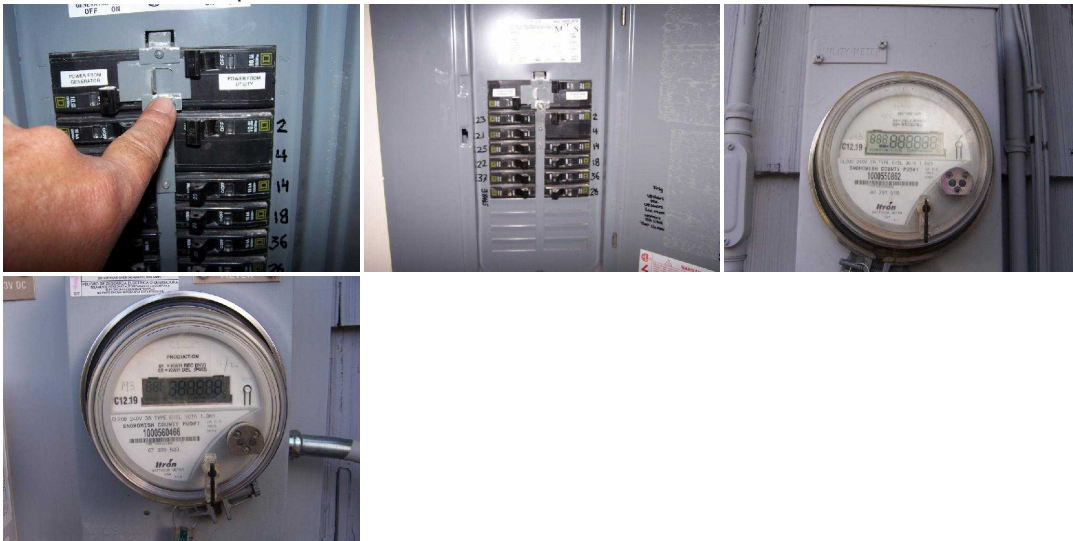
- 11. Maximum Capacity: 200 Amps
 - 12. Main Breaker Size: 200 Amps
 - 13. Breakers: Copper
 - 14. Fuses:
 - 15. AFCI: 110 volt
 - 16. GFCI: Kitchen and bathrooms
 - 17. Is the panel bonded? Yes No
- Sub panel Electric Panel _____
- 18. Manufacturer: Square D - I was unable to get the dead front off the panel. The dead front was screwed on to the panel.

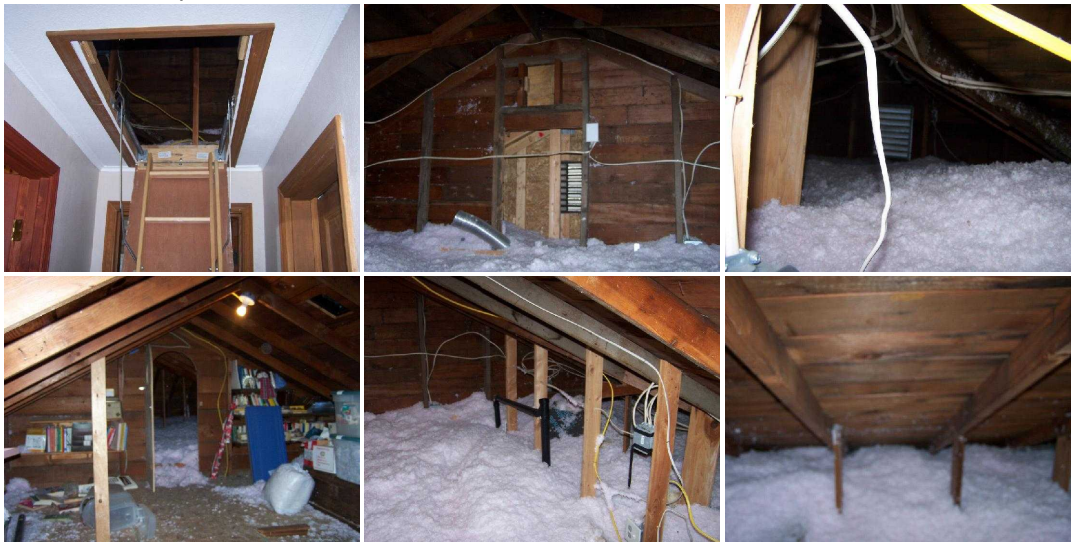
Main Attic

- 2. Unable to Inspect: 0%
- 3. Roof Framing: 2x4 Rafter
- 4. Sheathing: Plywood
- 5. Ventilation: Attic fan, Gable, roof and soffit vents
- 6. Insulation: Blown in fiberglass, Batts
- 7. Insulation Depth: 19+ inches
- 8. Vapor Barrier:

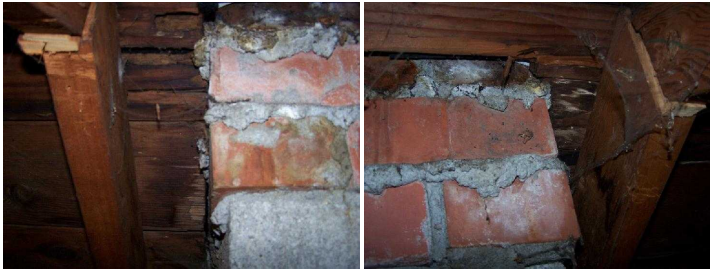
12. Moisture Penetration: Some signs of moisture around the chimney

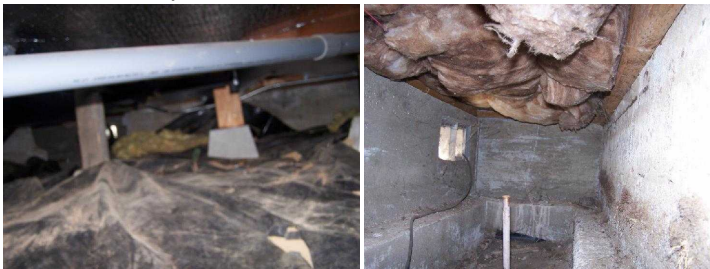
East Crawl Space

- 1. Method of Inspection: In the crawl space
- 2. Unable to Inspect: 0%

- 3. Access: Door in wall basement closet
- 4. Moisture Penetration: No moisture present at time of inspection

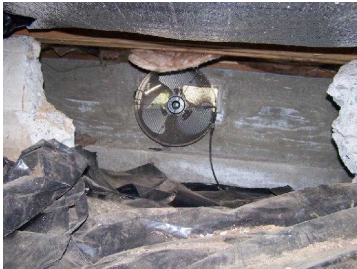
- 8. Insulation: Rigid polystyrene, Fiberglass
- 9. Vapor Barrier:
- 10. Sump Pump:
- 11. Electrical: 110 VAC - A junction box does not have a cover on it. Recommend an electrician to estimate and evaluate to install a cover on junction box.

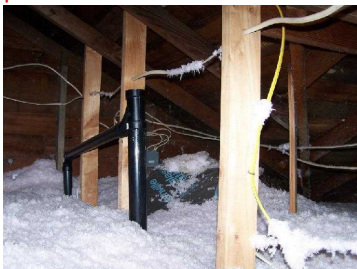
1. Service Line: Copper
2. Main Water Shutoff: Basement
3. Water Lines: Copper
4. Drain Pipes: ABS
5. Service Caps: Accessible
6. Vent Pipes: Galvanized, ABS - **The vent pipe for the plumbing terminates in the attic. Recommend a plumber to estimate and evaluate to terminate the vent threw the roof.**

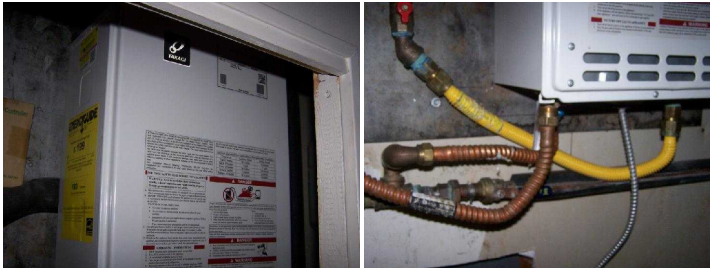
Basement Kitchen Water Heater

8. Water Heater Operation: Functional at time of inspection

9. Manufacturer: Takagi
10. Model Number: N/A Serial Number: N/A
11. Type: Natural gas Capacity: In line water system
12. Approximate Age: N/A Area Served: Whole building
13. Flue Pipe: Double wall
14. TPRV and Drain Tube: Copper TPRV/ Copper drain tube.

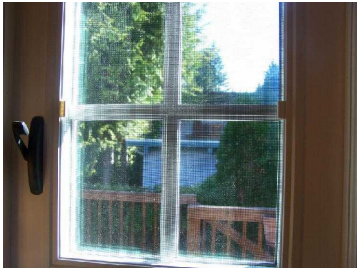
6. Windows: Vinyl casement - The window is not a privacy window. Recommend a glass company to install a privacy window.

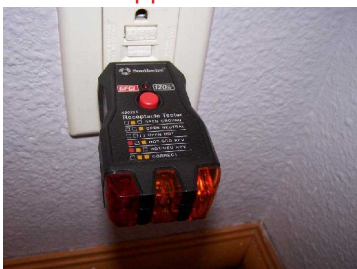
Basement Bathroom

17. Closet:
18. Ceiling: Texture paint
19. Walls: Texture paint
20. Floor: Tile
21. Doors: Hollow wood
22. Windows: Vinyl slider
23. Electrical: 110 VAC GFCI - *When I tripped the GFCI outlet there was an open neutral. It was fine before i tripped the outlet.*

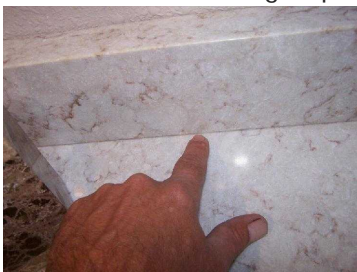
- 33. Closet: Large
- 34. Ceiling: Texture paint
- 35. Walls: Texture paint
- 36. Floor: Tile
- 37. Doors: Hollow wood
- 38. Windows: Vinyl casement
- 39. Electrical: 110 VAC GFCI
- 40. Counter/Cabinet: Granite and wood - There is no caulking between the counter and back splash.
Recommend caulking to prevent water from intruding behind the counter.

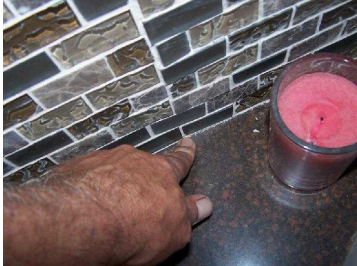
44. Shower/Surround: Fiber glass tub shower combo / tile surround - The caulking around the tub and wall is cracking. Recommend recaulking.

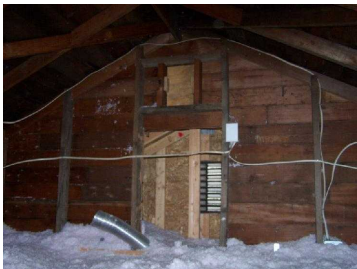
48. Ventilation: Electric ventilation fan and window - **The bath vent terminates into the attic. Recommend a contractor to estimate and evaluate to vent piping threwh the roof.**

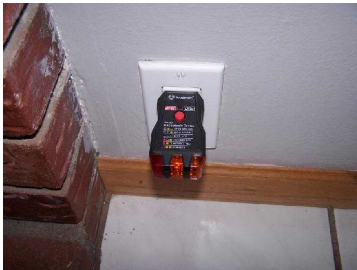
1. Cooking Appliances: N/A
2. Ventilator: N/A
3. Disposal: In-Sinkerator
4. Dishwasher: N/A
5. Air Gap Present? Yes No
6. Trash Compactor:
7. Refrigerator: N/A
8. Microwave: N/A
9. Sink: Stainless Steel
10. Electrical: 110 VAC GFCI - The outlet by the fire place has an open ground. Recommend an electrician to estimate and evaluate to fix open ground for electrical safety.

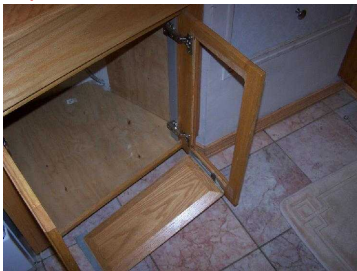
- 21. Cooking Appliances: N/A
- 22. Ventilator: N/A
- 23. Disposal:
- 24. Dishwasher: N/A
- 25. Air Gap Present? Yes No
- 26. Trash Compactor:
- 27. Refrigerator: N/A
- 28. Microwave: N/A
- 29. Sink: Stainless Steel
- 30. Electrical: 110 VAC GFCI
- 31. Plumbing/Fixtures: Stainless Steel
- 32. Counter Tops: Laminate
- 33. Cabinets: Wood - **The cabinet door is broken. Recommend a contractor to estimate and evaluate to repair the door.**

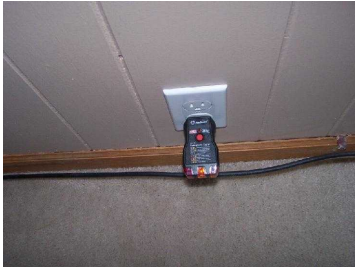
17. Electrical: 110 VAC - on the inside wall there is an open ground.

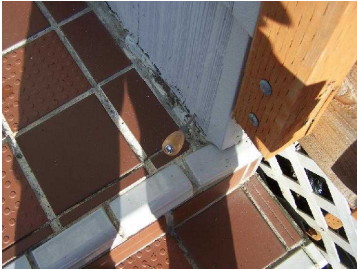
1. Entry Doors: Wood, Solid wood w/ Glass window, Glass French doors - **There is some rot on the siding at the back door. Recommend a contractor to estimate and evaluate to repair the siding.**

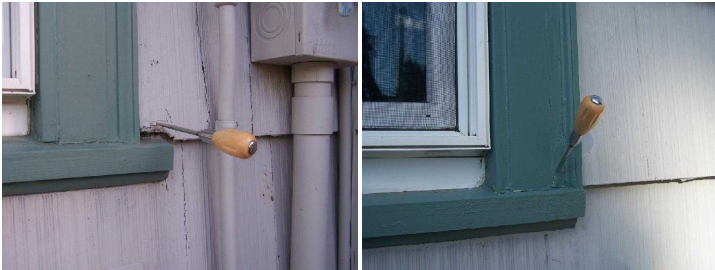
2. Windows: Vinyl slider - **The trim on the window in the front on the right side of the door has small amount if rot. The Back window also is showing some rot. Recommend a contractor to estimate and evaluate to replace the trim.**

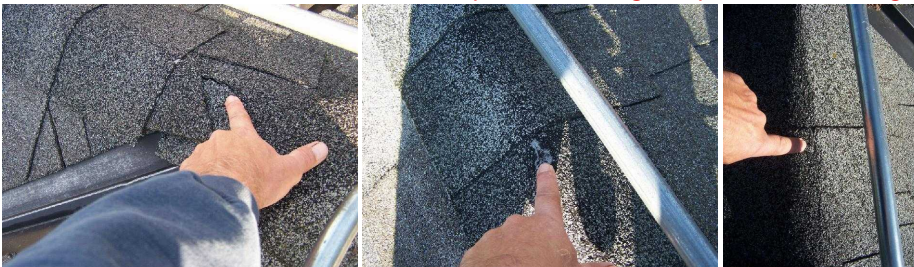
3. Main Roof Surface Material: Asphalt shingle - **Some of the roof shingles are broke, cracked or worn. Recommend a roofer to estimate and evaluate to replace the ridge cap that is not in good shape.**

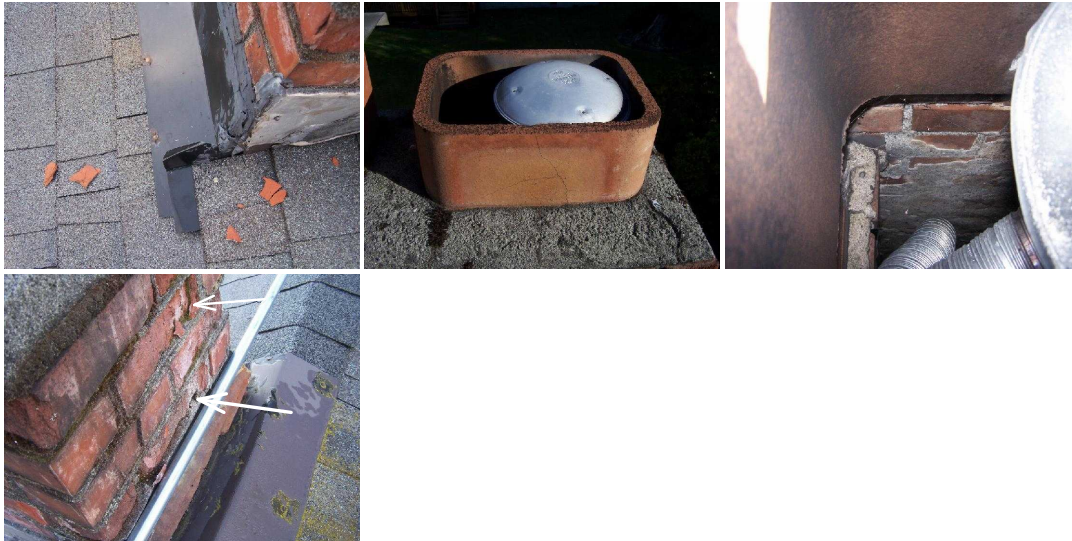
4. On ridge line, North Chimney Chimney: Brick, Metal pipe - **Some of the bricks are starting to flake off. Recommend repairing as necessary.**

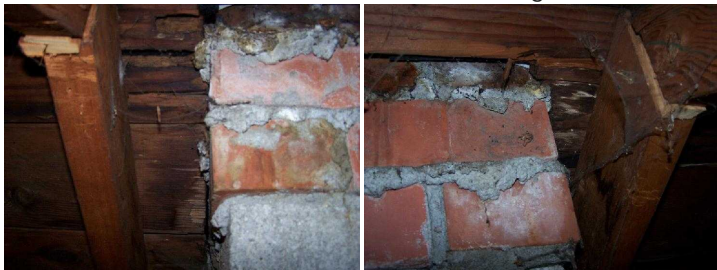
5. Main Attic Moisture Penetration: Some signs of moisture around the chimney

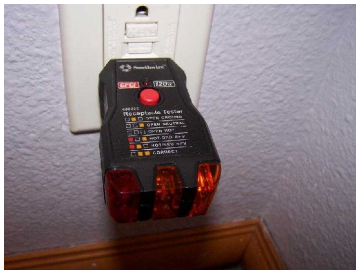
6. Basement Bathroom Electrical: 110 VAC GFCI - **When I tripped the GFCI outlet there was an open neutral. It was fine before i tripped the outlet.**

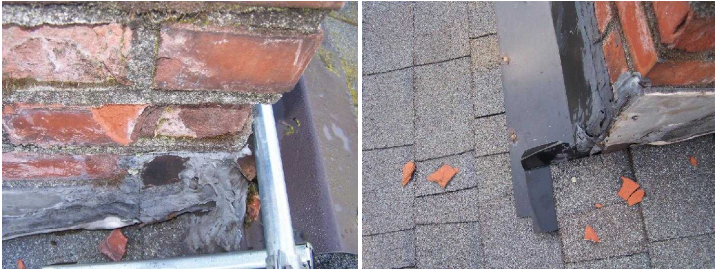
1. On ridge line, North Chimney Chimney Flashing: Galvanized - **Most of the flashing has been caulked. Recommend a chimney sweep to estimate and evaluate to replace the flashing.**

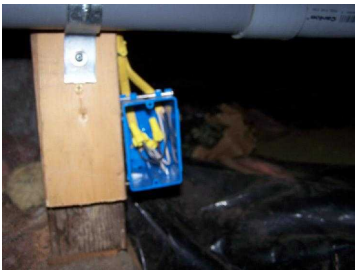
2. East Crawl Space Electrical: 110 VAC - **A junction box does not have a cover on it. Recommend an electrician to estimate and evaluate to install a cover on junction box.**

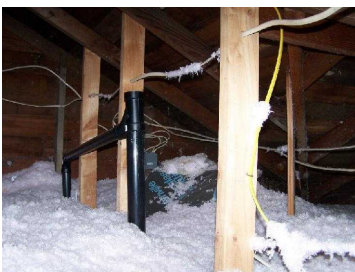
3. Vent Pipes: Galvanized, ABS - **The vent pipe for the plumbing terminates in the attic. Recommend a plumber to estimate and evaluate to terminate the vent through the roof.**

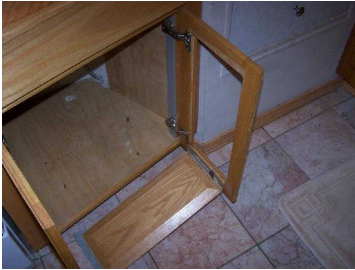
5. Basement Kitchen Cabinets: Wood - **The cabinet door is broken. Recommend a contractor to estimate and evaluate to repair the door.**
